Wire Rope Failures, Who is Accountable?

Wire Rope Failures

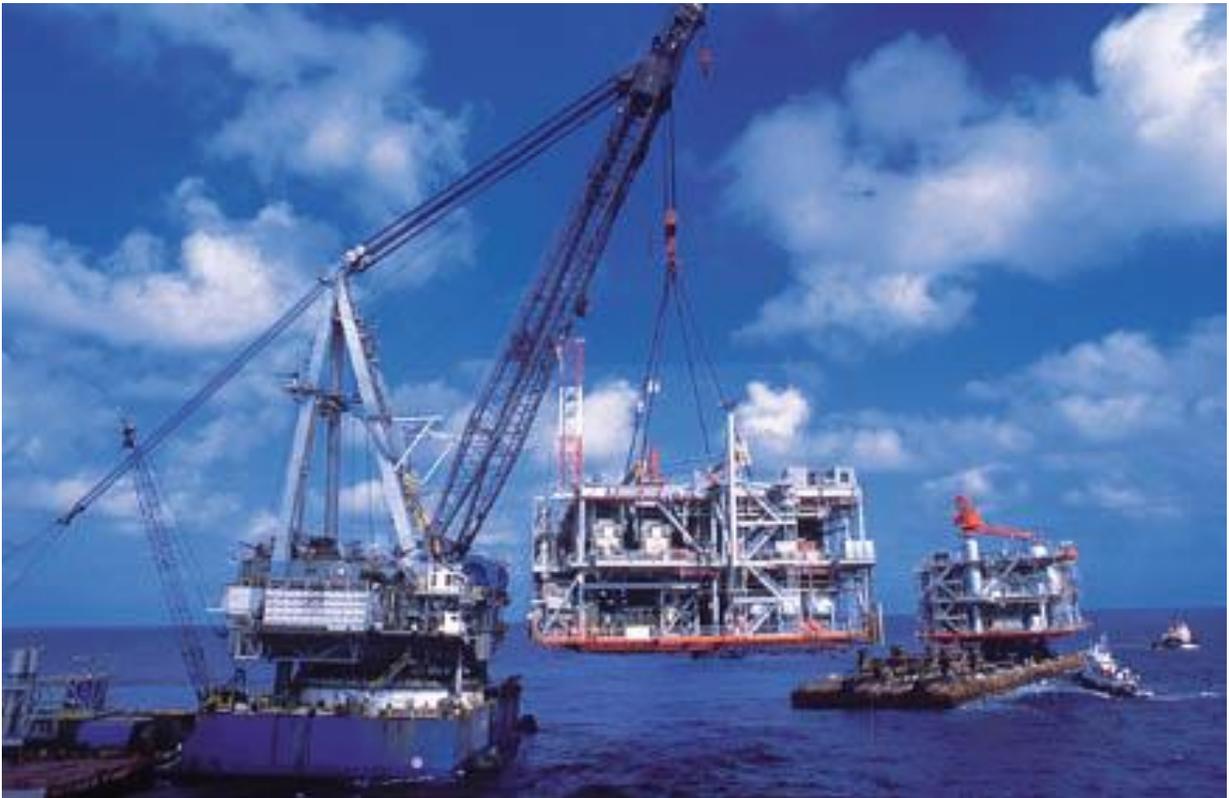
Figure 1. The Heavy Lift Vessel DB-50 is shown here lifting the North module of the Petronius compliant tower into place. The [ill fated South module](#) is visible in the background.

In 1998, a crane load line broke while lifting the south topside module of the [Petronius platform](#), dropping the module into the Gulf of Mexico. The cost was estimated to be around 116 million US dollars.

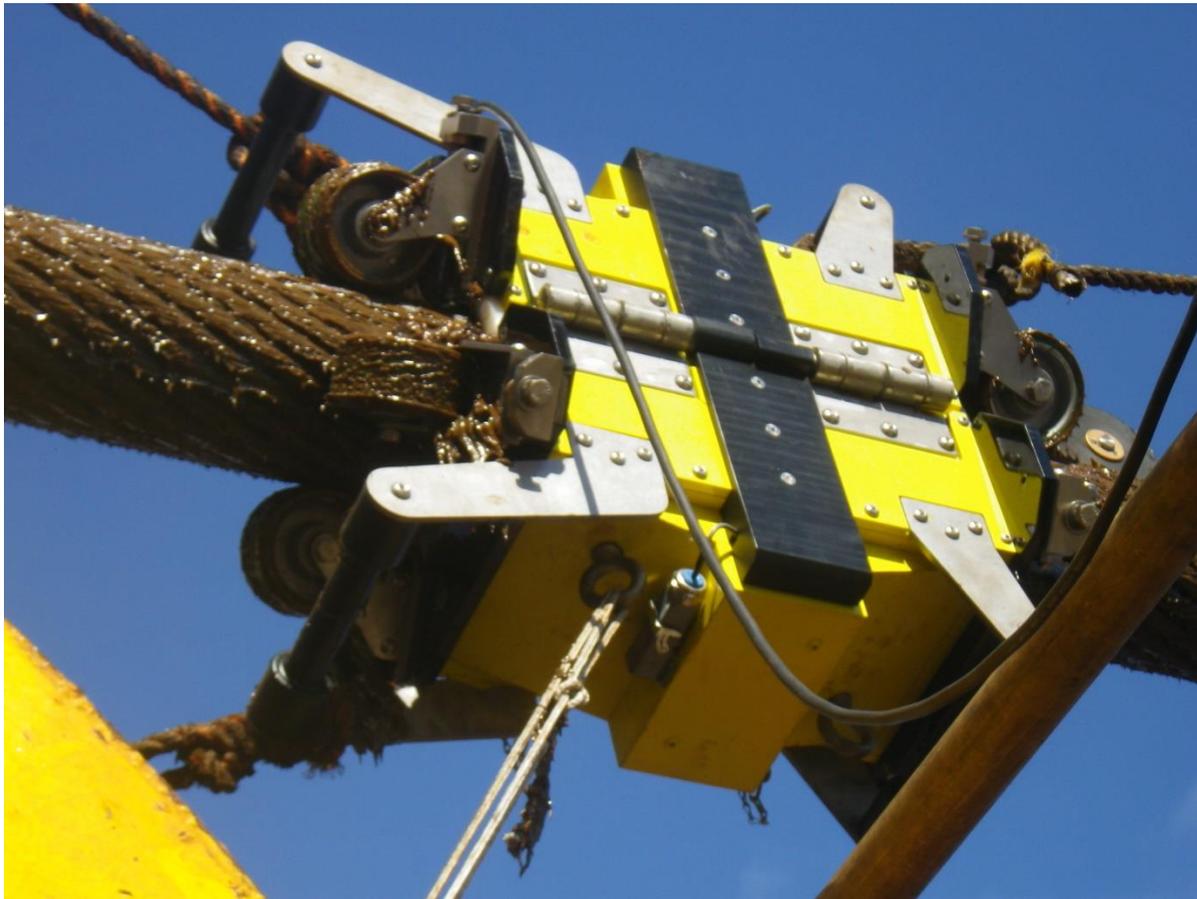
Figure 2. [Magnetic Testing \(MRT\) of 160 mm diameter A&R Winch Rope](#)

In 2014, a 2.3-kilometer section of steel pipe at the Roncador oil field off the coast of Brazil was dropped after a [160 mm diameter rope of an A&R winch](#) failed. The loss was around 55 million US dollars.

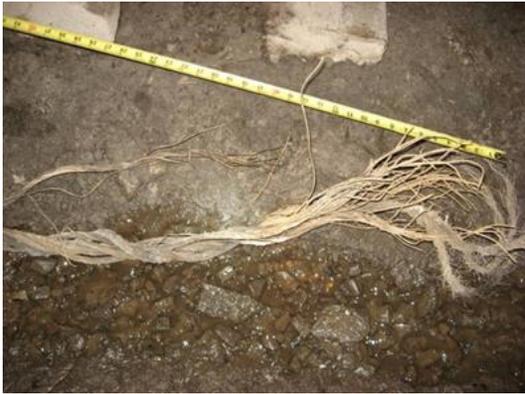
Figure 3. Underground Coal Mine [Fatal Hoisting Accident](#), October 27, 2009

Failed end of the wire rope (car side) following the accident.

Underground Coal Mine Fatality in West Virginia: On Tuesday, October 27, 2009, a 56 year old trackman was fatally injured. While the hoist was traveling up the slope, the hoist rope broke. This allowed the brake/mantrip car, mine locomotive and loaded rail car to run away down a 16 degree, 1,750 foot slope. The victim was at the bottom of the slope. Two miners were in the brake/mantrip car when the rope broke. They jumped out of the car and received non-life threatening injuries.

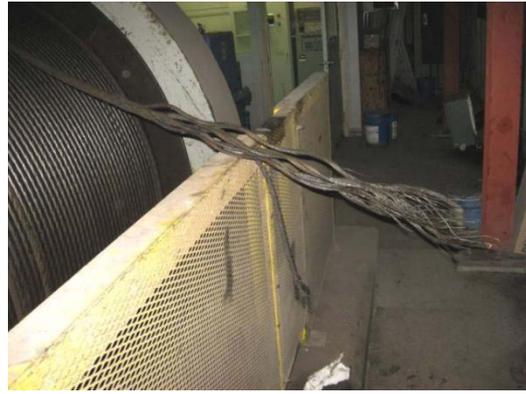
Failed end of wire rope (hoist drum side) following the accident.

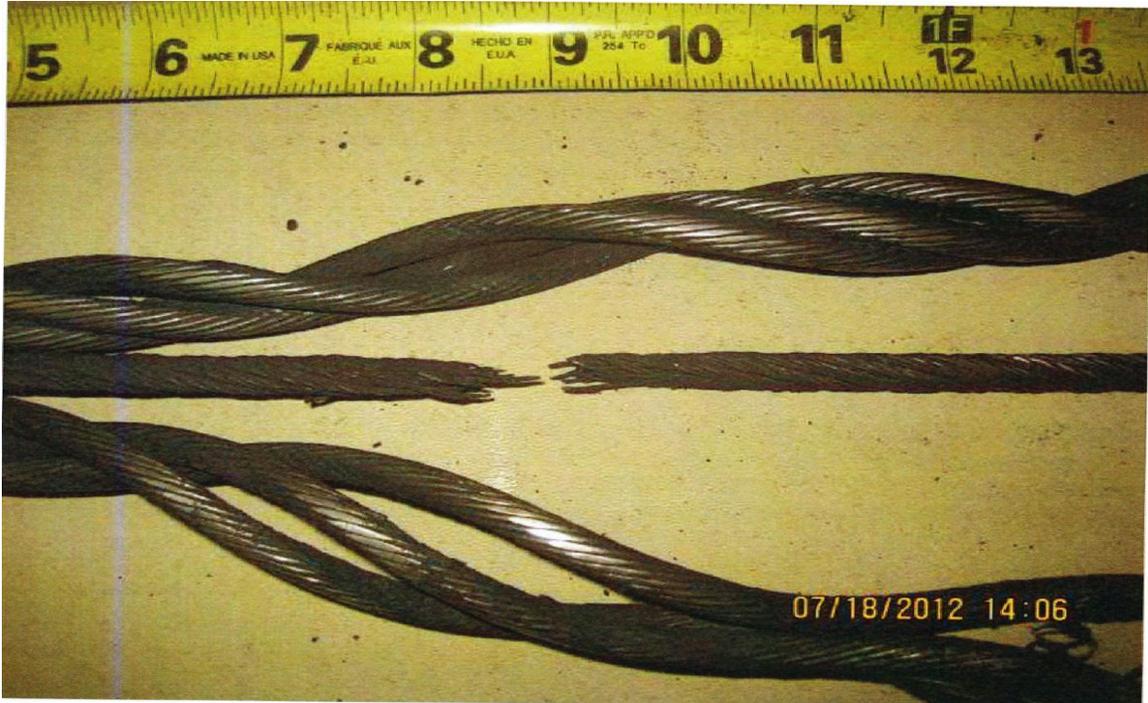
Figure 7. 7/8 inch diameter, 6 x 25 FW RRL IWRC wire rope after disassembly

The retired portion of rope was disassembled by removing the outer strands from the rope. As this process occurred, a section of the IWRC fell out of the rope. All of the wires in the core of the rope had deteriorated due to corrosion. This section of the hoist rope is shown in Figure 7.

Based on the test results obtained from NDT, approximately 150 feet of hoist rope were immediately retired from service. A visual examination of the damaged portion of the retired hoist rope was conducted at the mine site. No broken outer wires were identified. The outer strands of the affected portion of the rope were removed to expose the damage to the core. Based on disassembly of the rope and on the visual examination, it was apparent that this section of hoist rope met the retirement criteria specified by Title 30 CFR 75.1434 (a), (d), and (h).
